# Abbreviated Analysis of Brownfields Cleanup Alternatives and Community Involvement Plan

Old Headquarters-North Building Brownfield Site, 529 N. 16th St., Durant OK 74701

## ASBESTOS INSPECTION REPORT

***Inspection performed at:***  
Old Headquarters Building (North Side)  
529 N. 16th St, Durant, OK 74701.

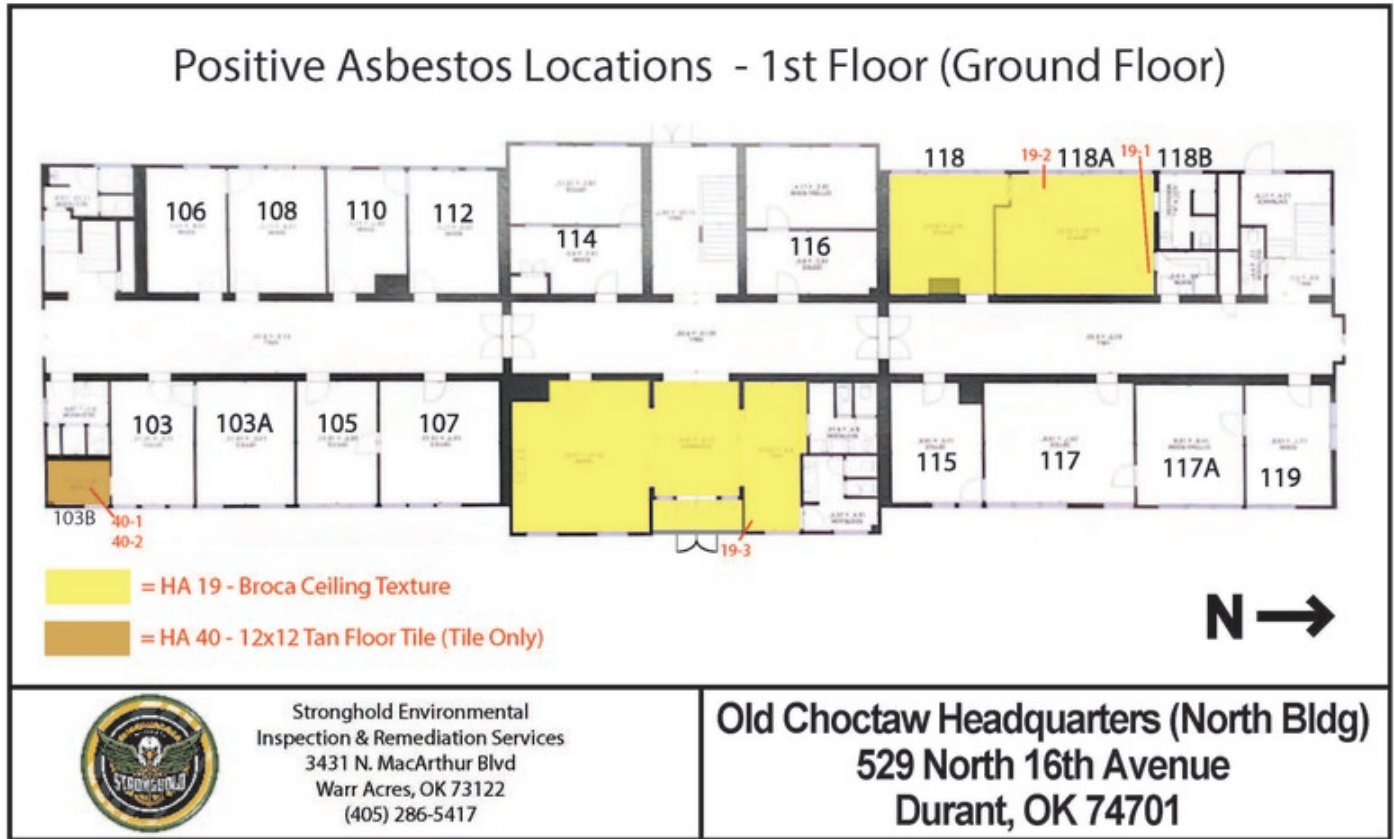
The ceiling texture is found on the 1st floor lobby and adjoining rooms and in the assistant chief's office. The floor tiles are found in the closet of Room 103. Both of which are found on the 1st floor. No other asbestos containing materials were identified, except for the presumed asbestos -containing fire doors on all three floors.

[Appendix B: Photos](#) has identifying photos for ceiling textures.

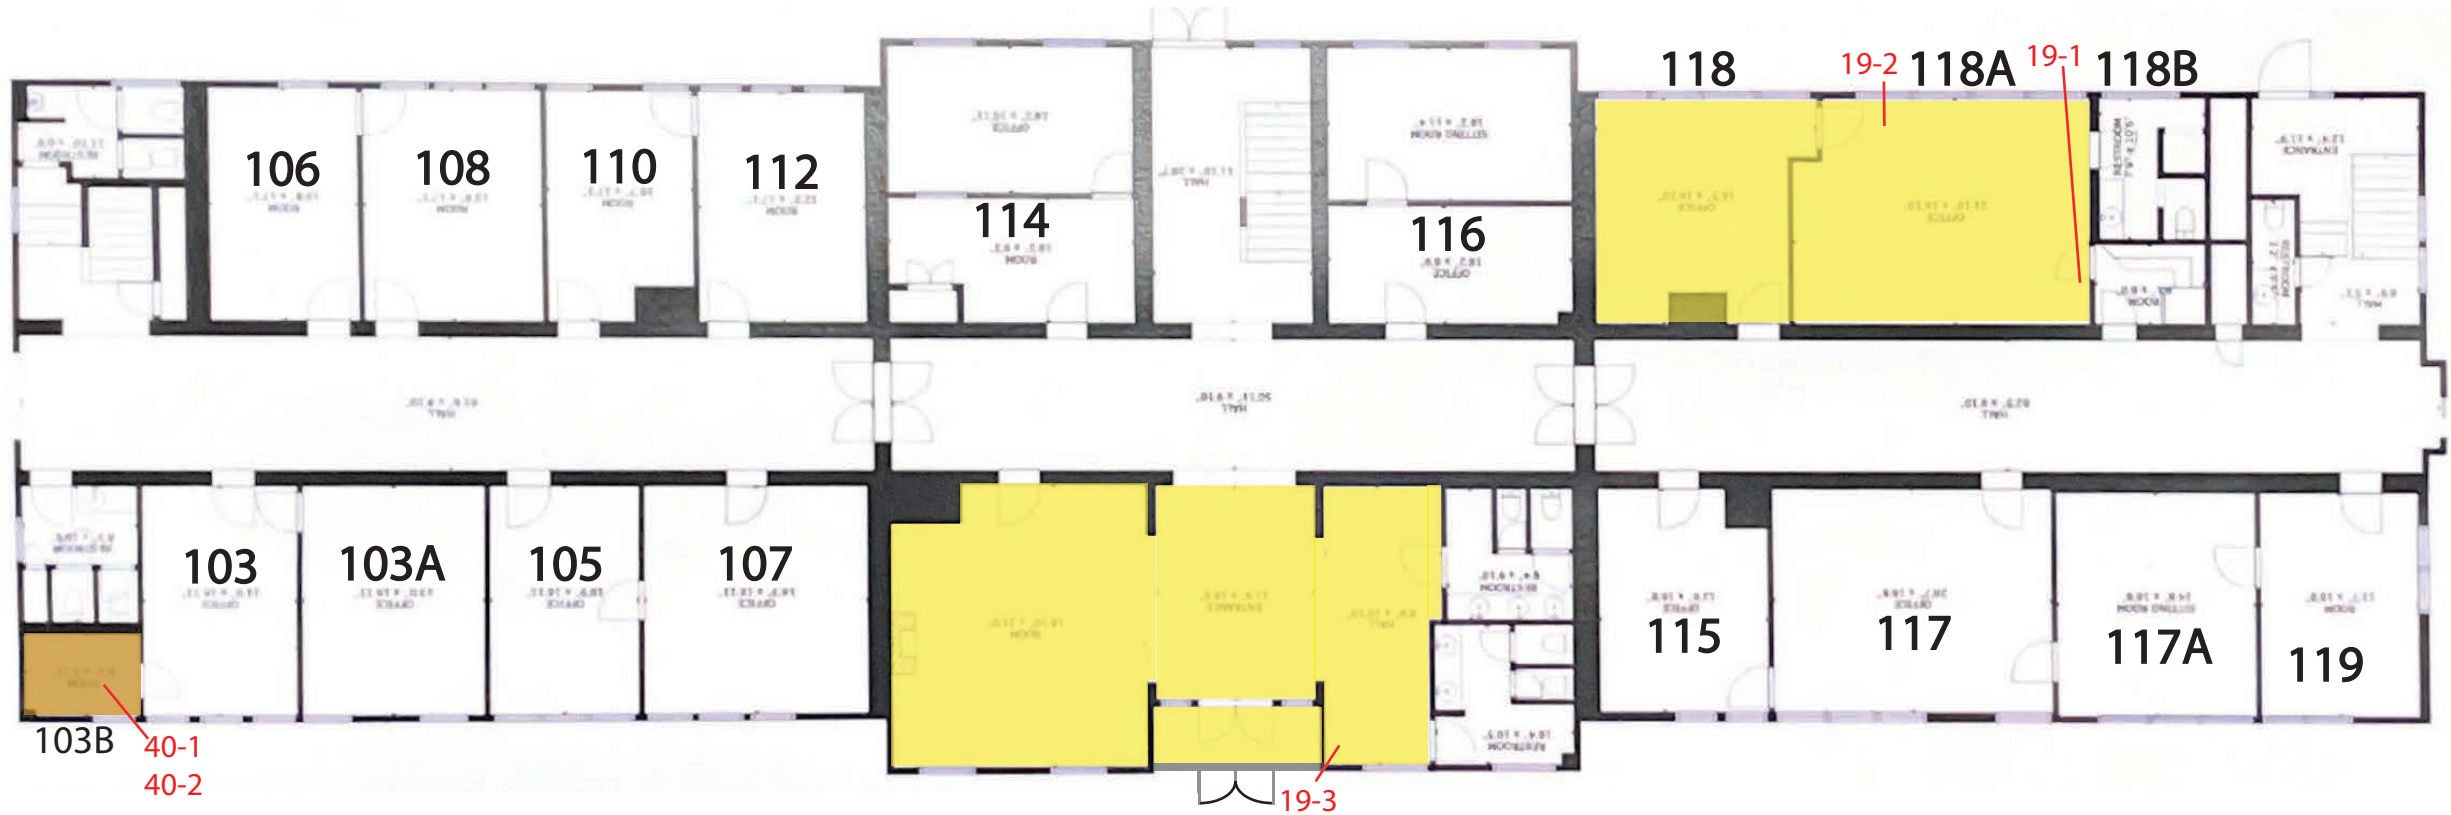
# Positive Asbestos Locations - 1st Floor (Ground Floor)

Homogeneous Area 40 (HA-40), consisting of 12x12 tan floor tiles (tile only), tested positive for 3% chrysotile asbestos and was found in the closet of Room 103. The remaining 62 homogeneous areas tested negative for asbestos-containing materials, indicating no further asbestos presence in those sampled sections of the building.

Recommendation: Proceed with Alternative #3: Abatement of HA-19 ceiling texture and HA-40 floor tile under a licensed project design with independent air monitoring and clearance. Manage PACM fire-rated doors in place under the AMP unless future reuse dictates removal under a separate design.

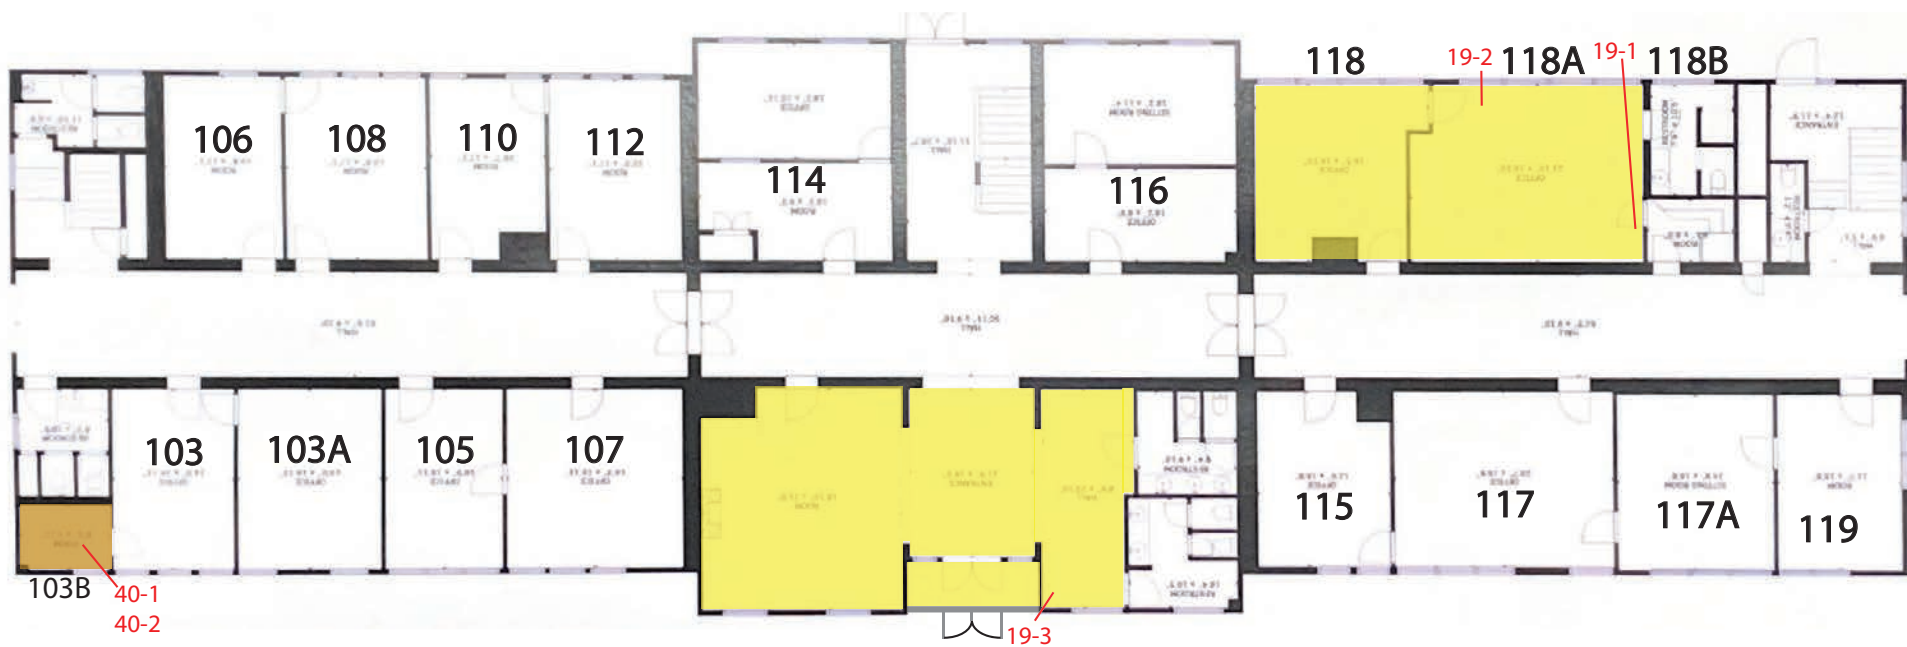
# Positive Asbestos Locations - 1st Floor (Ground Floor)

- = HA 19 - Broca Ceiling Texture
- = HA 40 - 12x12 Tan Floor Tile (Tile Only)
